KCF Technologies Asset Case Studies

Homogenizer Motor

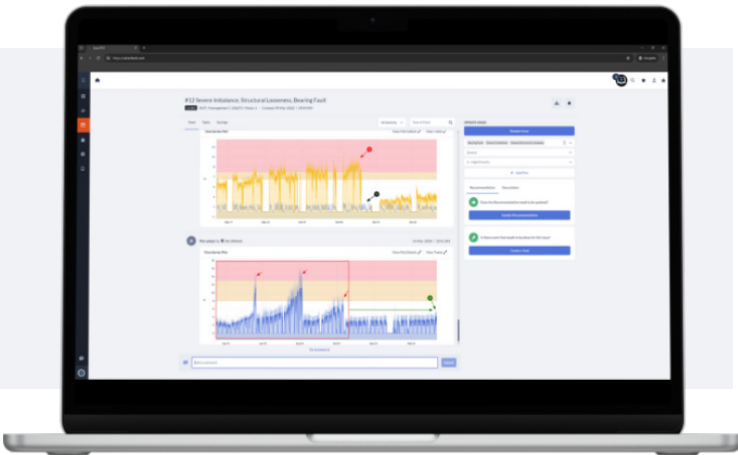
Severe imbalance and structural looseness with a bearing fault (fluting).

An inconsistent operation of the Homogenizer C Motor DE Bearing, with heightened Peak Accel readings was identified. The main problems were increased vibration and indications of looseness, primarily at the non-drive end compounded with bearing fault frequencies associated with fluting.

A change in sensor position was performed to gather more accurate data. Following continued abnormal readings, the NDR bearing was replaced on August 5, with temporarily reduced the peak accel. Additionally, adjustments to the pulley and belts were made and a soft foot check was conducted. A speed study suggested the opportunity to lower the operating frequency (Hz) of the motor. On August 18, variable frequency drive wiring was replaced due to fluting found in the recently replaced non-drive end bearing. Despite these measures, vibrations continued to rise. This prompted the recommendation to replace the entire motor with one equipped with ceramic bearings to mitigate electrical issues and better manage the operational demands.
