KCF Technologies Asset Case Studies

Main Drive Motor

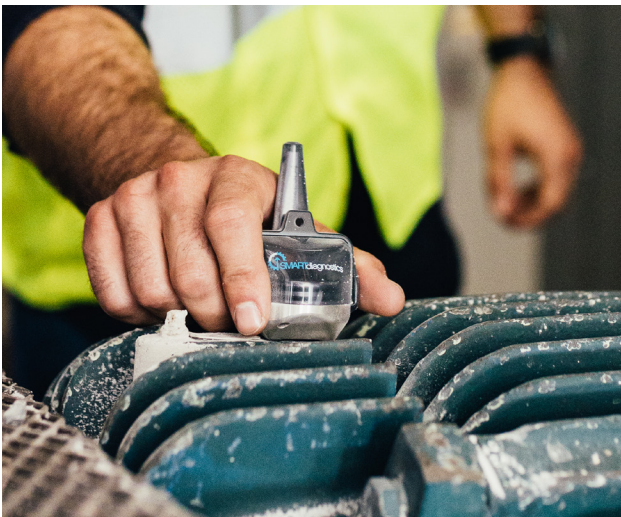
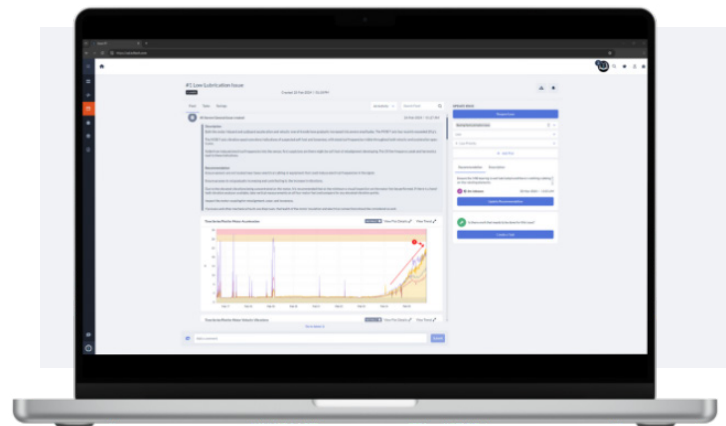
Both the motor inboard and outboard acceleration and velocity overall trends gradually increased into severe amplitudes. The MOB Y axis exceeded 20 g's. The MOB Y axis vibration spectrums showed indications of suspected soft foot and looseness, with electrical frequencies visible throughout both velocity and acceleration spectrums. Aside from induced electrical frequencies into the sensor, first suspicions are there might be soft foot of misalignment developing.

A SENTRY Analyst ensured the MIB bearing was well lubricated and there was nothing rubbing on the rotating elements. They also verified the NU240 C3 Bearing on non-drive end and replaced the motor bearings.
