KCF Technolgies Asset Case Studies

Vacuum Pump

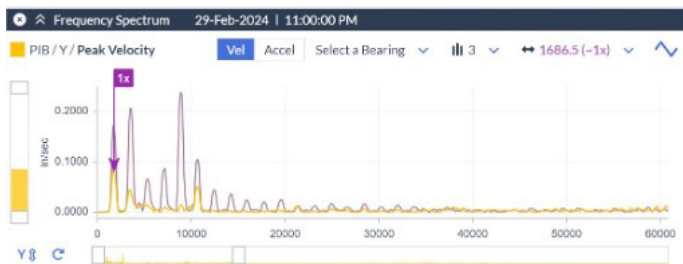
After inspection, the problem was discovered to be coupling wear and rotating looseness.

Following alignment and the coupling replacement, levels immediately returned to a healthy point and have stayed there since.
